Number 948

**Date:** 12/19/2019

**Subject:** F800 Engineering Improvements

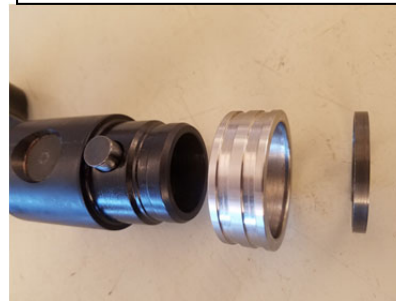
1. Connecting Rod assembly/Pump pin connection – More robust pin retainer design.  
All F800 units manufactured prior to November, 11 2019 have the original design and should be updated. Customer should order kit (P/N 17W625) per pump lower and file a warranty claim for the parts and the labor to install.

Removal of retaining

Retaining Ring and Pin  
Retaining Collar Removed
